Opera Assessment Report Revision 2

Independent Assessment of Eskom's Operational Situation

August 2023

Client:	National Treasury of South Africa	
Project No:	NT015/2022	
Report Title:	Opera Assessment Report – Revision 1	
Report No:	2 NT_Eskom	
Main Authors:	Bartosz Zajda (Dornier) Manswet Banka (Dornier) Klaus Bransch (Dornier) Vladan Dokic (Dornier) Pieter Janse van Rensburg (Dornier) Dr. Thomas von Schieszl (Dornier) Jörg-Schulte Trux (KWS) Ralf Wiescher (KWS) Rainer Zobel (KWS) Axel Meschbiz (RWE) Petros Terzis (RWE)	Volkmar Bobon (STEAG) Dietmar Breuer (STEAG) Dr. Ruth Egyptien (STEAG) Werner Renk (STEAG) Sener Günes (vgbe) Bernhard Michels (vgbe) Dr. Mark Newby (vgbe) Dr. Claudia Stockheim (vgbe) Dr. Oliver Then (vgbe) Dr. Christian Ullrich (vgbe) Dr. Claudia Weise (vgbe)
Date of Issue:	August 2023

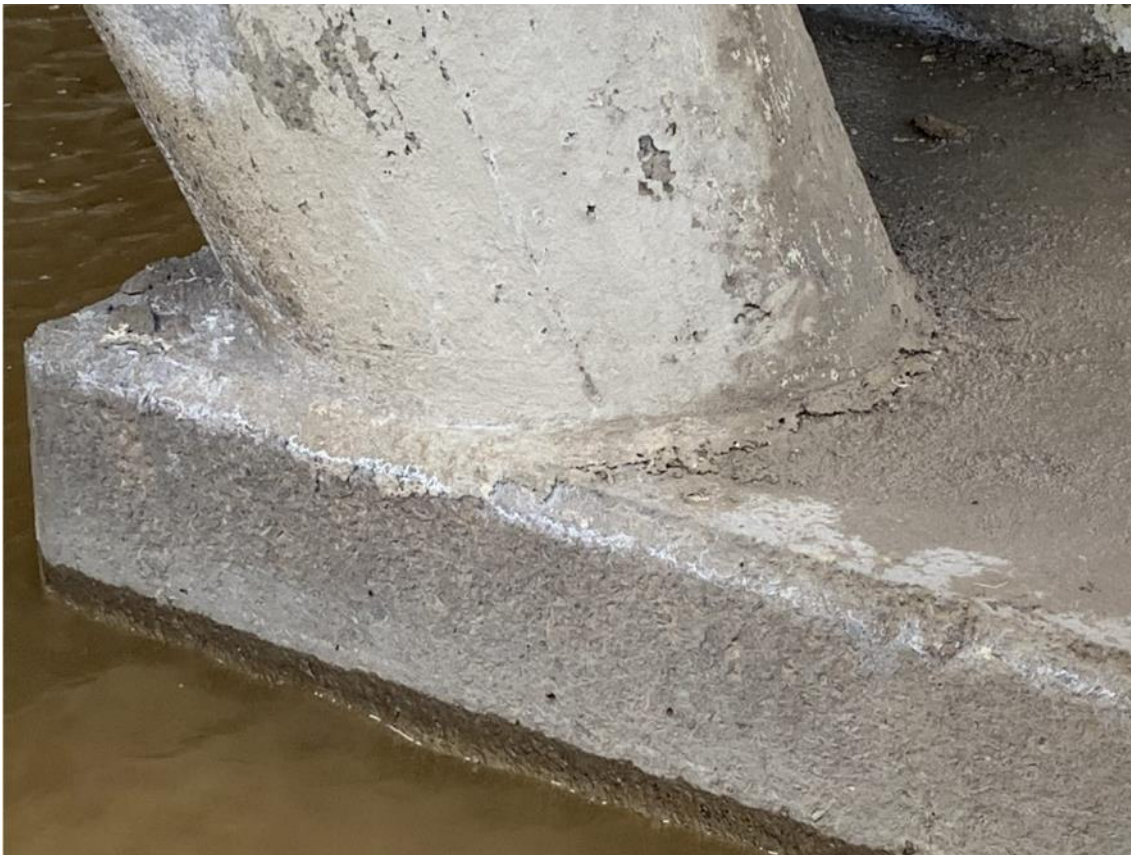
Figure 189: Condition of the cooling towers and cooling water at Tutuka

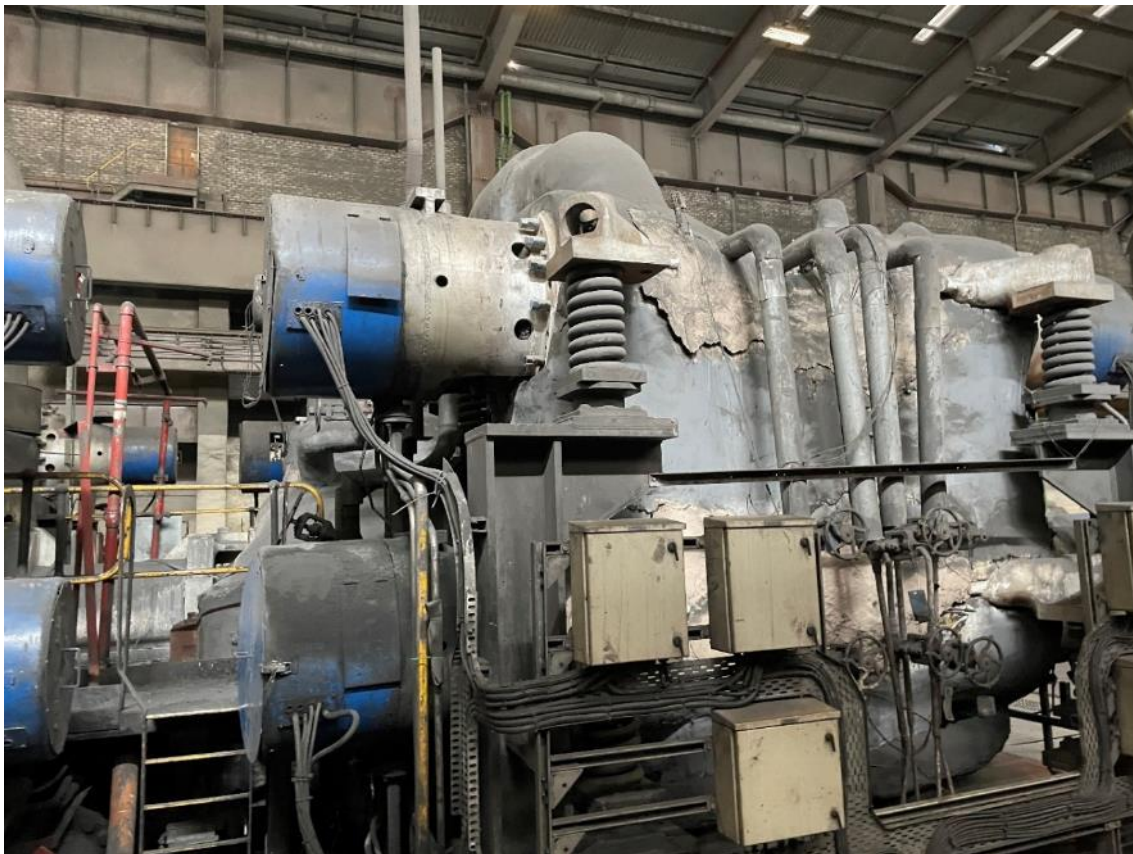
Figure 190: Poorly-cleaned turbine with cracked spray insulation at Tutuka

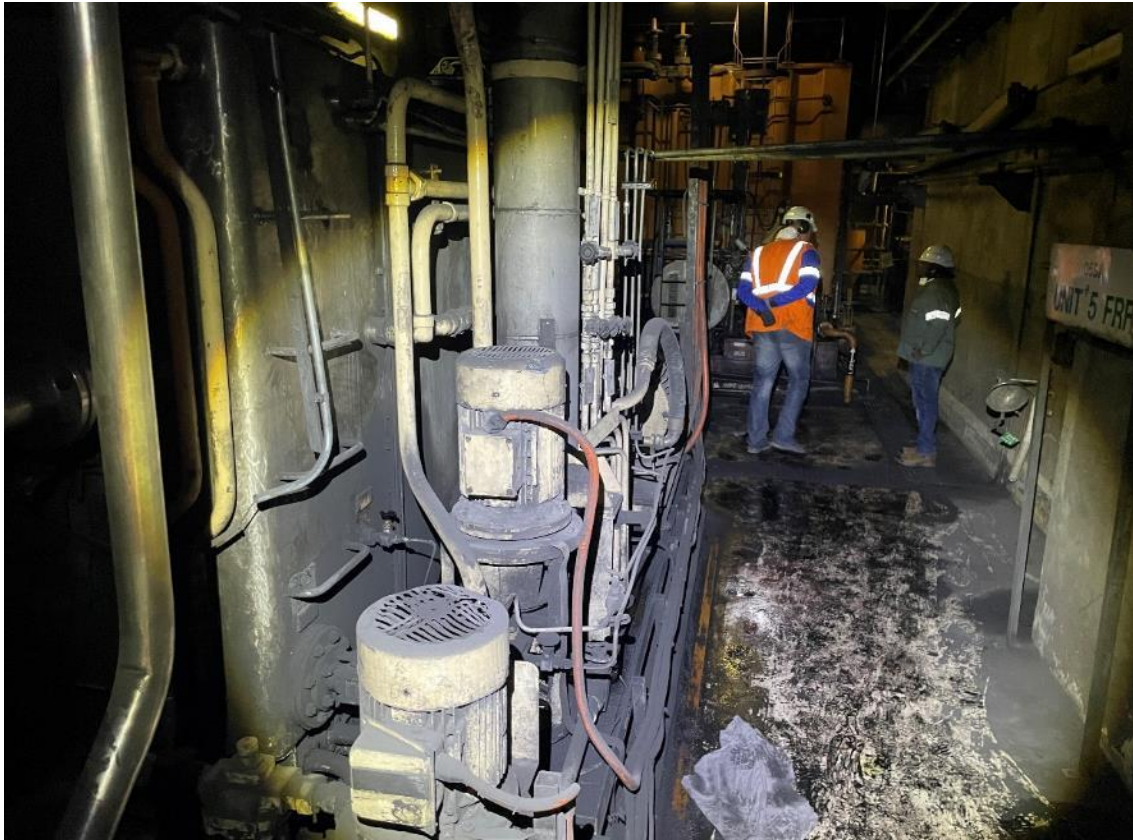
Figure 191: Tutuka's tank room for turbine lube oil – with poor housekeeping
